## PHOTOGRAMMETRY – CASE STUDY

### OSP-EAST CABLE – [REDACTED]

### Phase II – Post Rock Dump

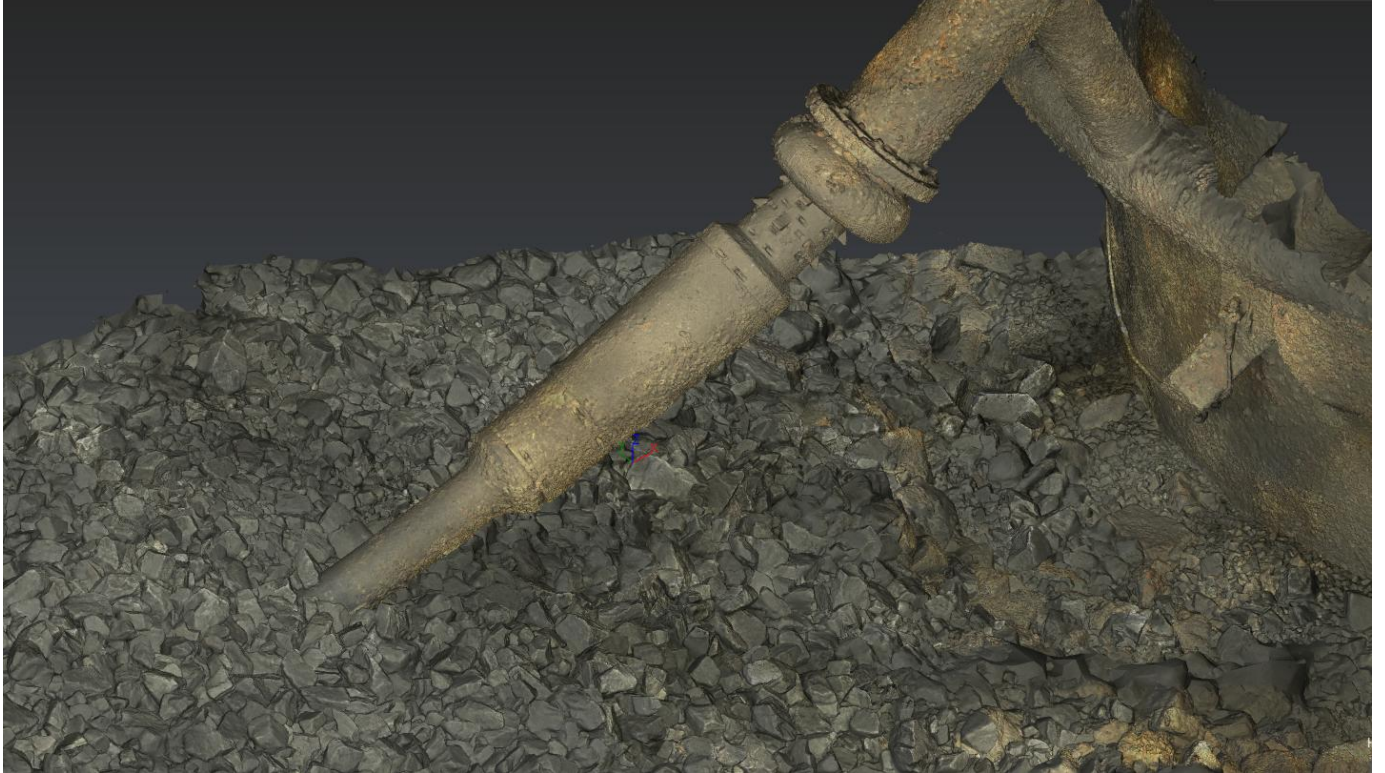
*Image showing the Dense Cloud 3D model of the anomaly area on the OSP East CPS cable after the rock dump operations*

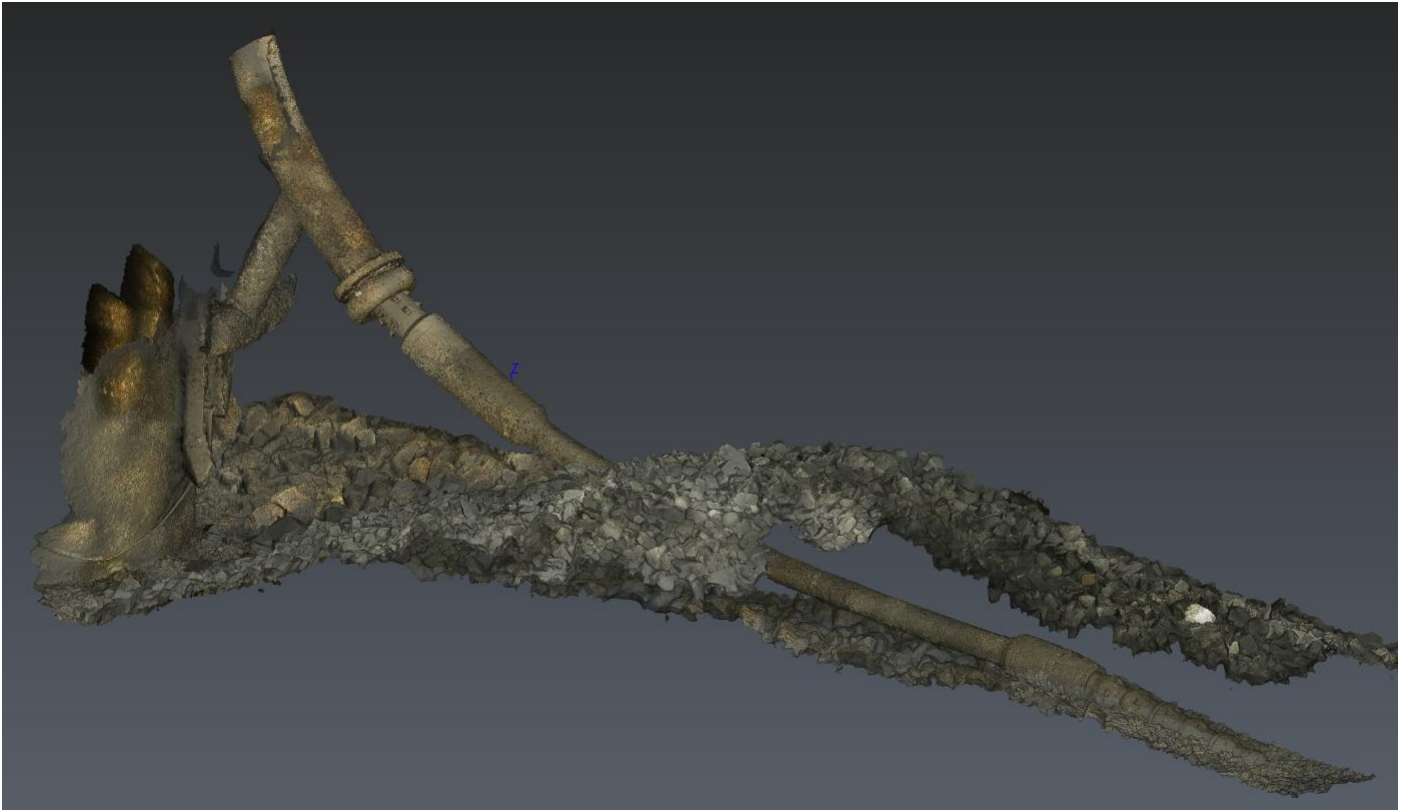
*Image showing the overlay of both Mesh 3D models from phase I and phase II of the OSP East CPS cable at from touchdown to bellmouth*
